PTL Project XXXXX-XX  
Wall Friction Study  
Sample Report

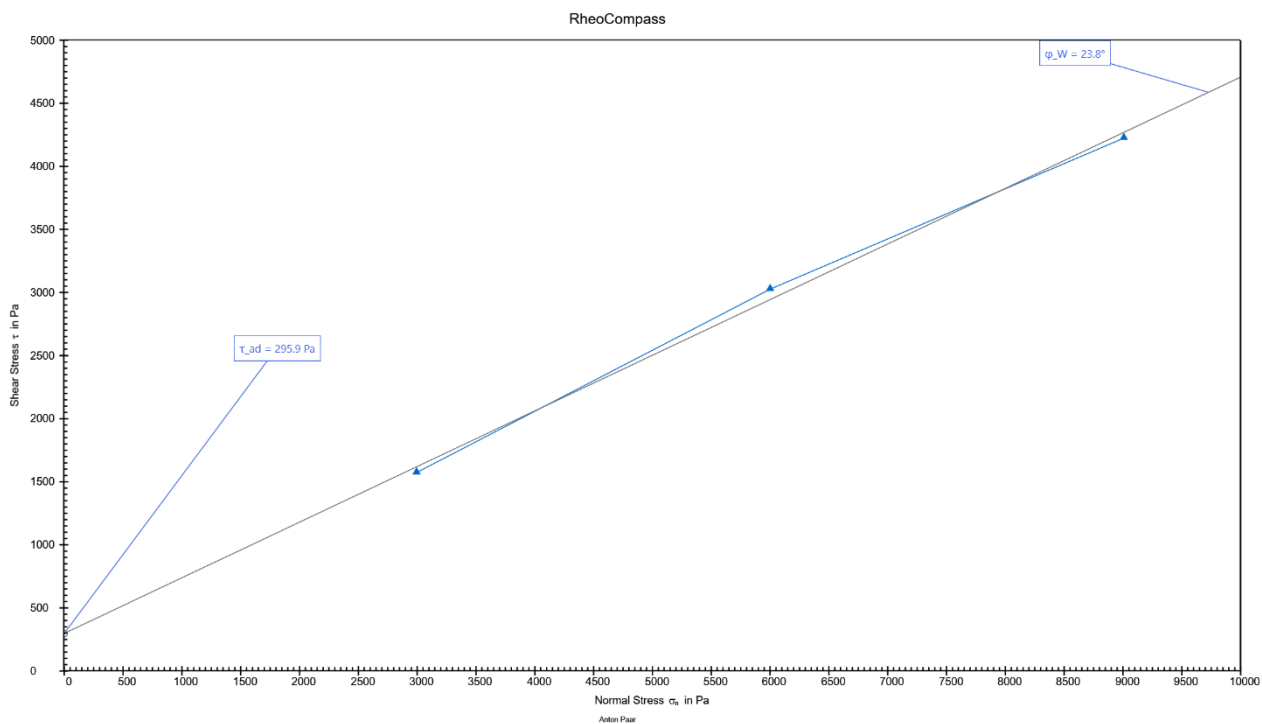
Sample Name  
Wall Failure locus function  
 $\tau_{ad} = 295.9$  Pa,  $\phi_W = 23.8^\circ$

Figure 17: Wall Friction – Shear stress as a function of normal stress with a pre-shear stress of 9kPa.
